## Villa Royale

Hong Kong, China (2016)

## BACKGROUND

## SOLUTION

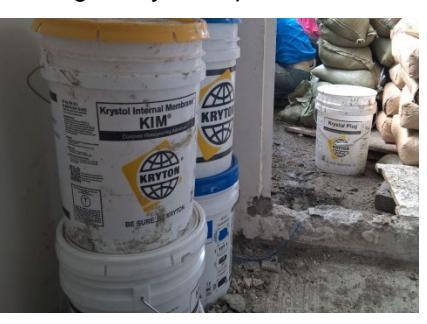
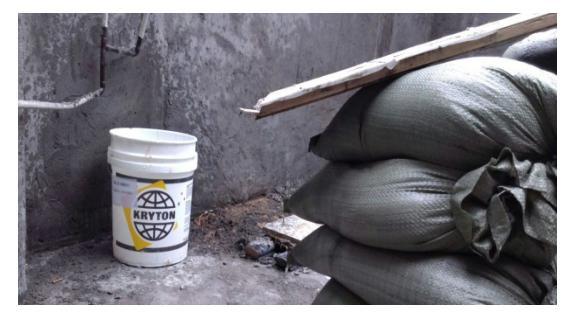
In short, the city was in need of residential buildings built to last. The Villa Royale was one such building. However, during its construction, workers did apply a traditional external waterproofing membrane, which eventually failed, leading to a leak in the building. To halt that leak in its tracks, the Villa Royale's repair team knew they'd need an innovative waterproofing solution.

The contractor on the project recommended the use of Kryton's repair solutions to fix the damaged area of the concrete caused by the failed membrane. These solutions included the use of several main products: Krystol Plug, KIM, Krystol Bari-Cote, and Krystol T1. The workers applied the first three products to the damage around the Villa Royale's roof. The plug's rapid-setting and high-compressive strength allowed the team to stop any water from passing through. KIM then enabled the surrounding concrete to protect itself from the leaking water, giving it the ability to chemically react to water and create needle-shaped crystals to block it. And the Bari-Cote helped resurface the damaged concrete.

For extra protection, the workers also applied Krystol T1 to the inside and outside of the damaged area of the concrete. As a crystalline waterproofing slurry treatment, Krystol T1 uses the same technology as KIM to ensure the concrete remains permanently protected from water. All of which reliably stopped the flow of water and ensured the concrete would not leak even with its original membrane damaged beyond repair.
