# NYU Langone Medical Center Foundation Repairs

New York, NY, USA (2017)

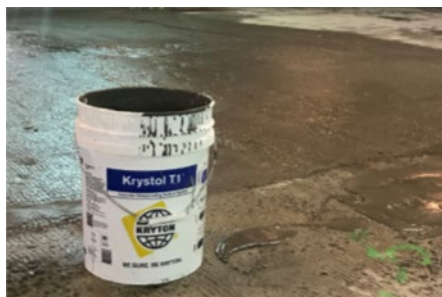
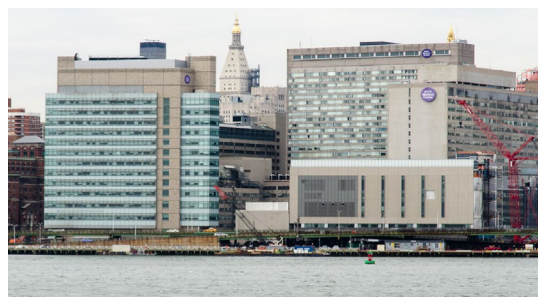
As part of this project, Gregory Maugeri from Dry Concrete worked with Langan in New York for several years on the use of Kryton's crystalline products to protect the lower levels of the NYULMC building. As a result, the Dry Concrete team took the lead on repairing the area first. They permanently fixed leaking cracks with Krytol Plug and Krytol Repair Grout, which combined a rapid-setting hydraulic cement with a crystalline slurry that can chemically block water from entering concrete. Then, they chiseled out non-leaking cracks and applied Krytol Repair Grout to protect them from future leakage.

Once they had addressed the cracks, the full slab and wall area was coated with Krytol T1 to waterproof the surrounding concrete. Some sections of this concrete were in poor condition, however. So those areas were removed and replaced with new concrete that was treated with KIM, an integral waterproofing admixture.

For further protection, Dry Concrete installed Kryton's Krytol Waterstop System to ensure there was a watertight joint between the old and the new concrete.
