Lorenzetti Acres Ltd. Dairy Farm

Hope, BC, Canada

PRODUCT USED:
Hard-Cem®

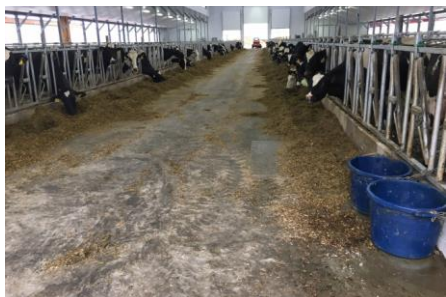
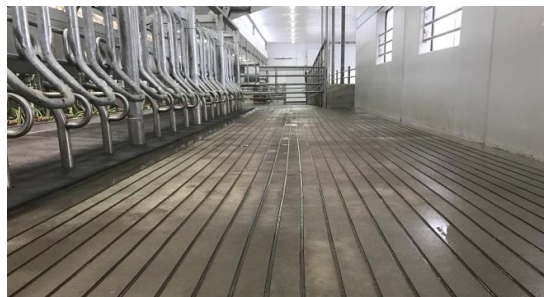
To combat the concrete's deterioration problem, Mardina Construction Ltd. proposed that they use the admixture Hard-Cem to integrally harden the concrete. After reviewing the proposal, Kerkhoff Engineering Ltd. was also on board. As a result, the construction team added Hard-Cem at the time of batching to the concrete, significantly reducing field application time. Then, they poured Hard-Cem concrete into the milking and loafing barn slabs, which need to withstand high abrasion and erosion, and the vertical silos, which are subjected to regular high-pressure power washes. After 28 days of the concrete curing, they then used a mini groover with diamond blades to cut grooves that were 13 mm (0.5 in) in width and depth and had 76 mm (3 in) of spacing for the textured traction finish.

The end results were impressive. By using Hard-Cem to reduce concrete wear and maintain the concrete's traction finish, Lorenzetti Acres Ltd. found their dairy production went up while their operational costs went down. The erosion resistance from Hard-Cem maintained concrete panels, rigorous quality, and cleanliness standards and increased the mechanical and hydraulic functionality of the new dairy barn. That allowed people, animals, and equipment to safely traverse across concrete surfaces. It also reduced equipment wear and tear while preserving operational efficiency, making the new barn a clean, non-hazardous environment built for dairy success.
